**VENTFORT HALL  
APPLICATION FOR CPA FUNDING – TOWN OF LENOX**

Project Name: Restoration of Chimneys on the Mansion

Ventfort Hall is requesting support from Lenox CPA funds to restore and rebuild four massive chimneys on the mansion roof that have seriously deteriorated and are in danger of collapsing. This project is critical to our mission to restore and preserve the 1893 mansion and grounds built by George and Sarah Morgan, to open it to the public as a museum dedicated to the history of the Gilded Age, and to serve as a cultural center presenting the work of regional performing and visual artists. (Continued on next page.)

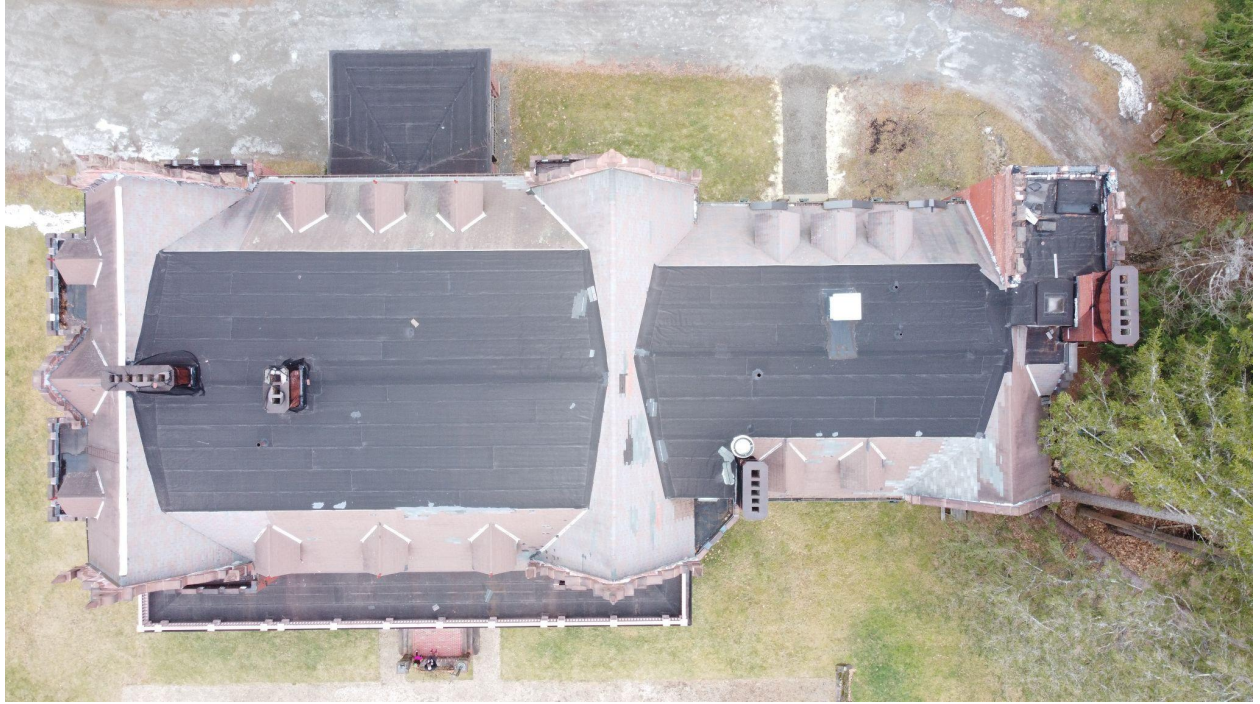
Aerial view of the roof of Ventfort Hall, all four chimneys visible

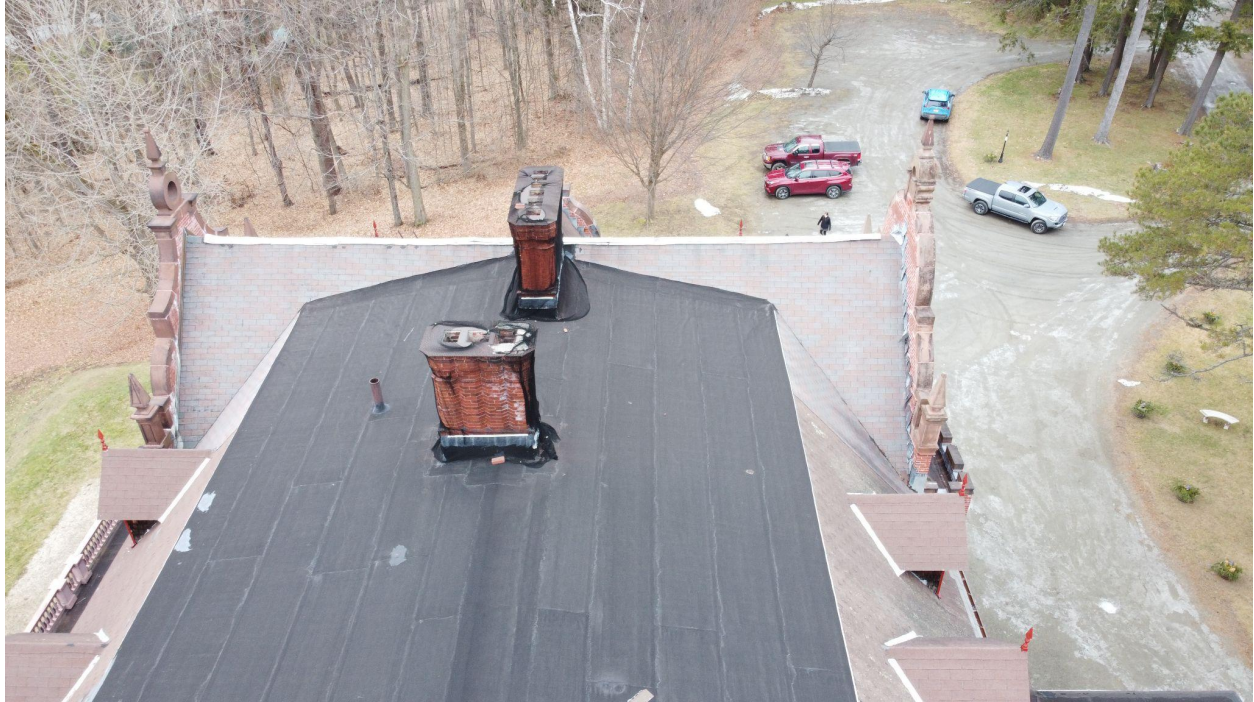
Chimneys on the West side of the roof. Chimneys currently netted for temporary safety.

The chimneys on the mansion roof have severely deteriorated and now pose a danger to the mansion itself as well as to staff and visitors. Many of the bricks on the chimneys have lost their mortar and have begun falling off, currently being caught by temporary netting. Falling bricks can cause severe harm to the roof or to patrons on the ground. Moreover, should a chimney collapse completely, we do not have adequate documentation to replicate the ornate brick details and corbeling to re-create the ornately constructed chimneys.

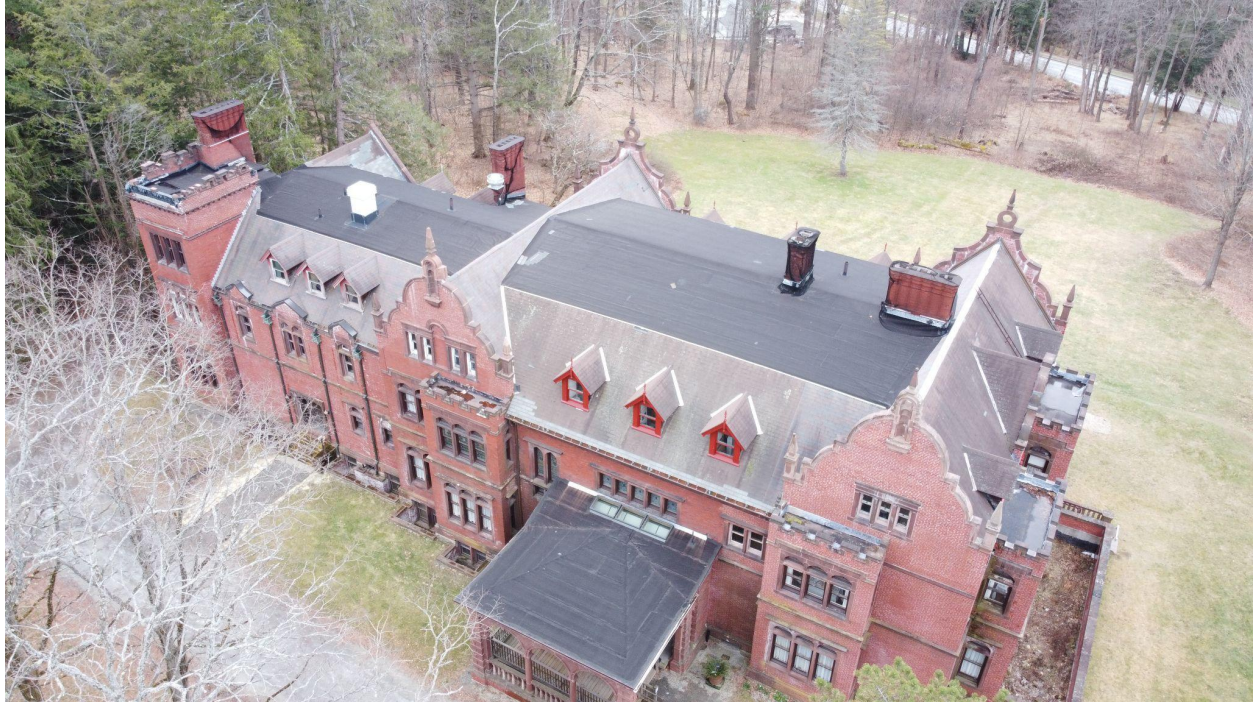
View of Ventfort Hall roof, all four (netted) chimneys visible. (Note that the tower on the left has been worked on since this photo was taken.)

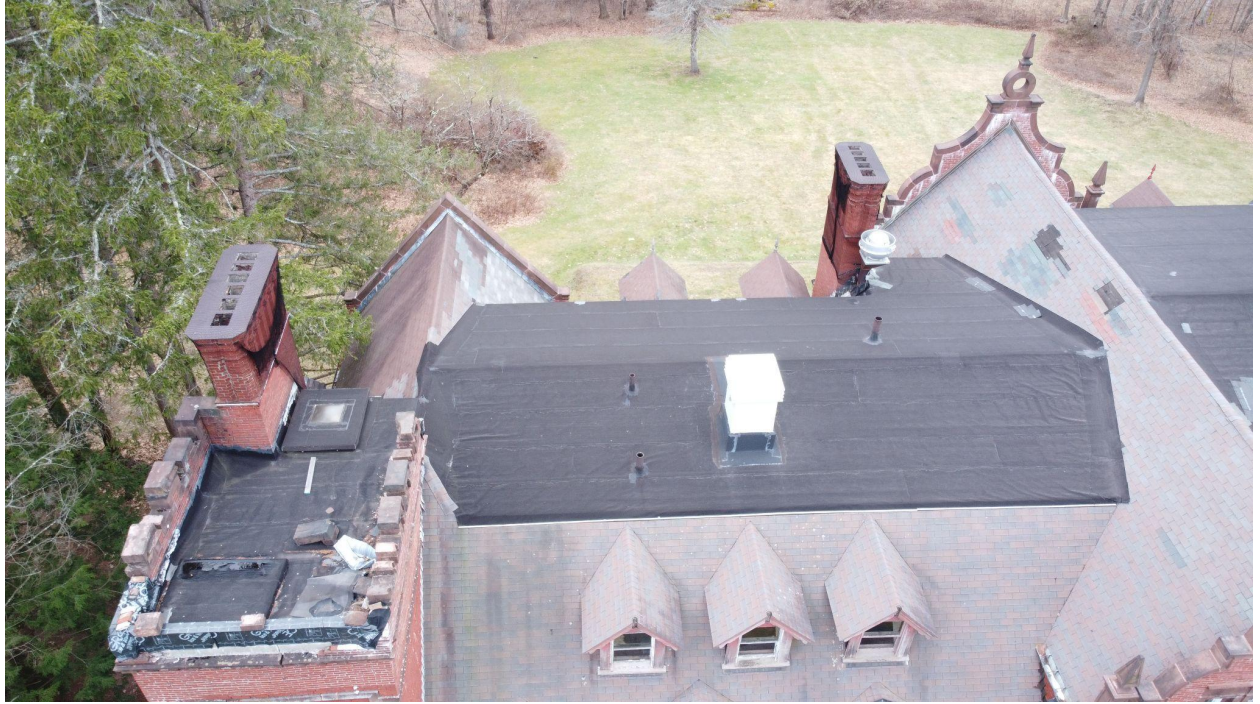
Chimneys on the East side of the house

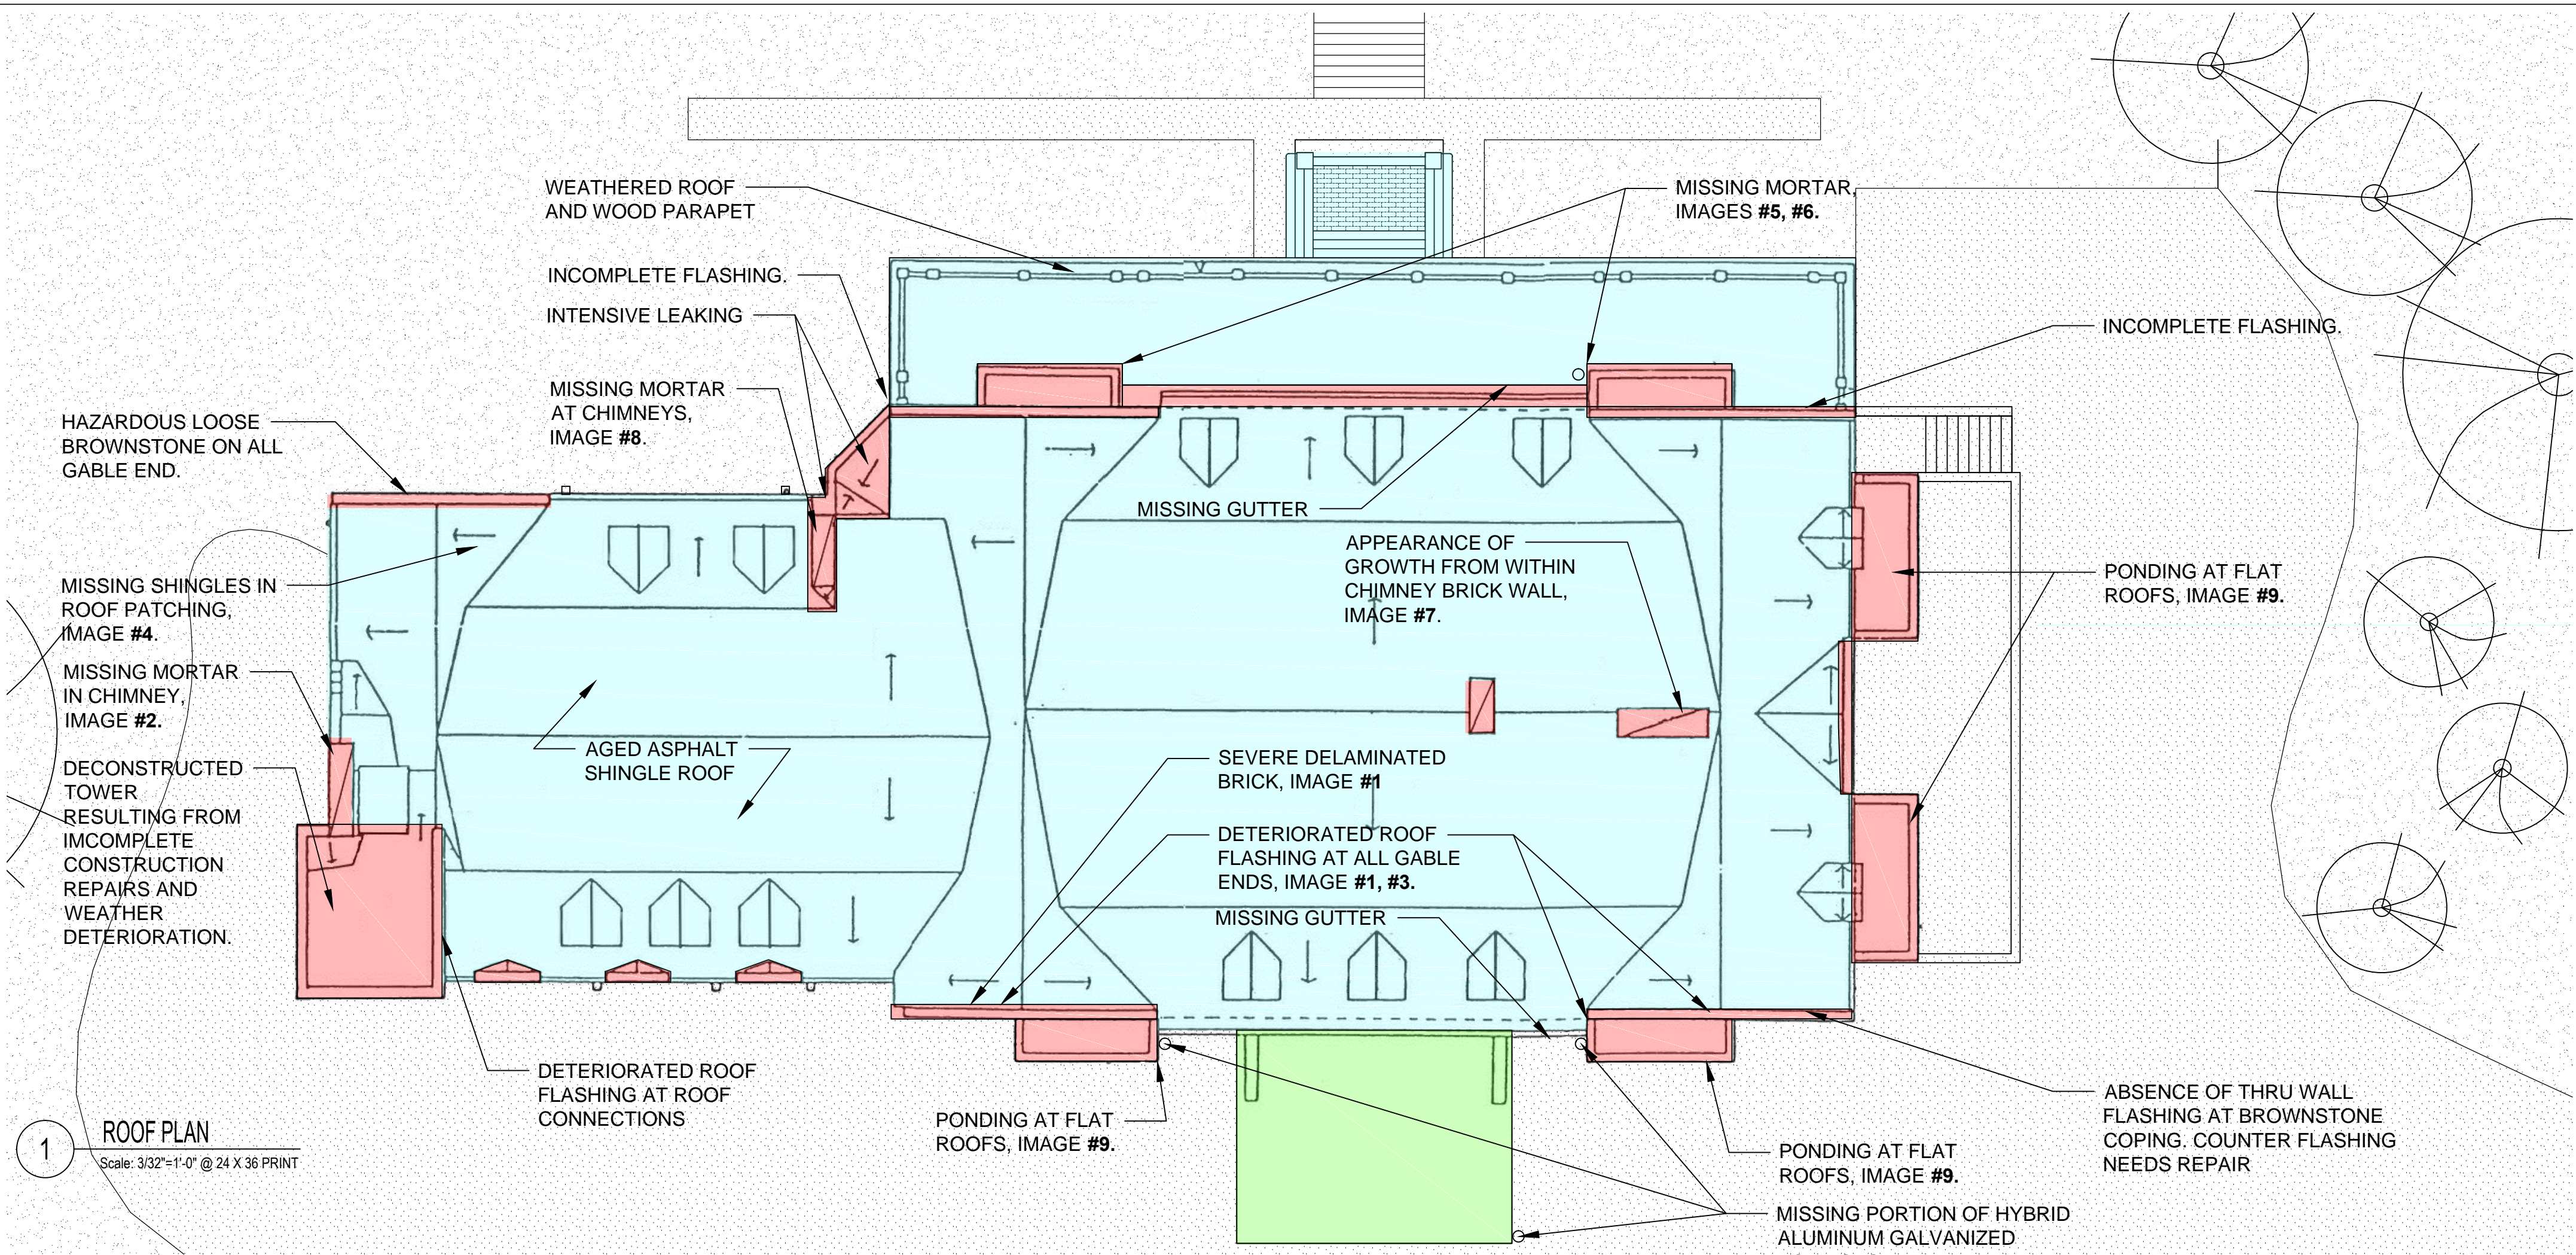
EX-104

**1 ROOF PLAN**  
Scale: 3/32"=1'-0" @ 24 X 36 PRINT

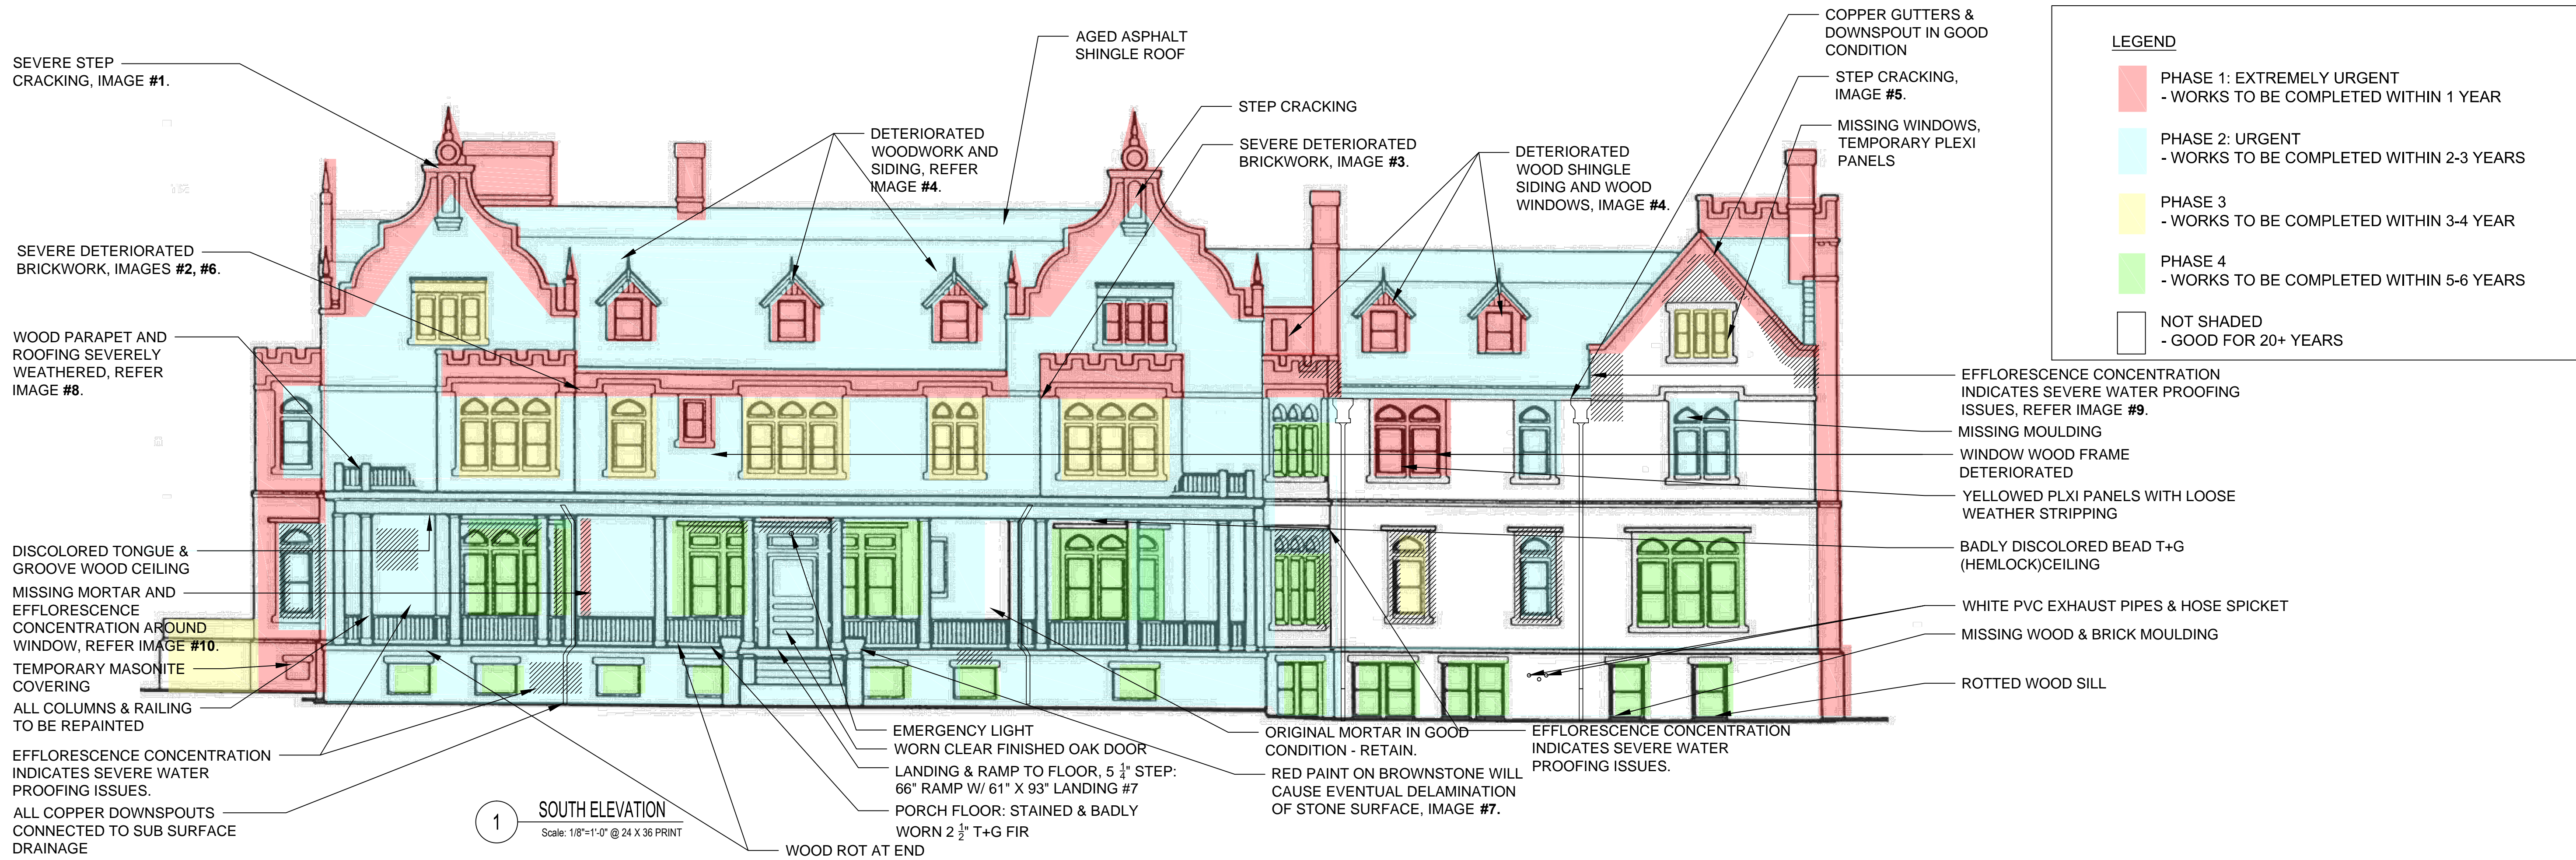
1 SOUTH ELEVATION  
Scale: 1/8"=1'-0" @ 24 X 36 PRINT

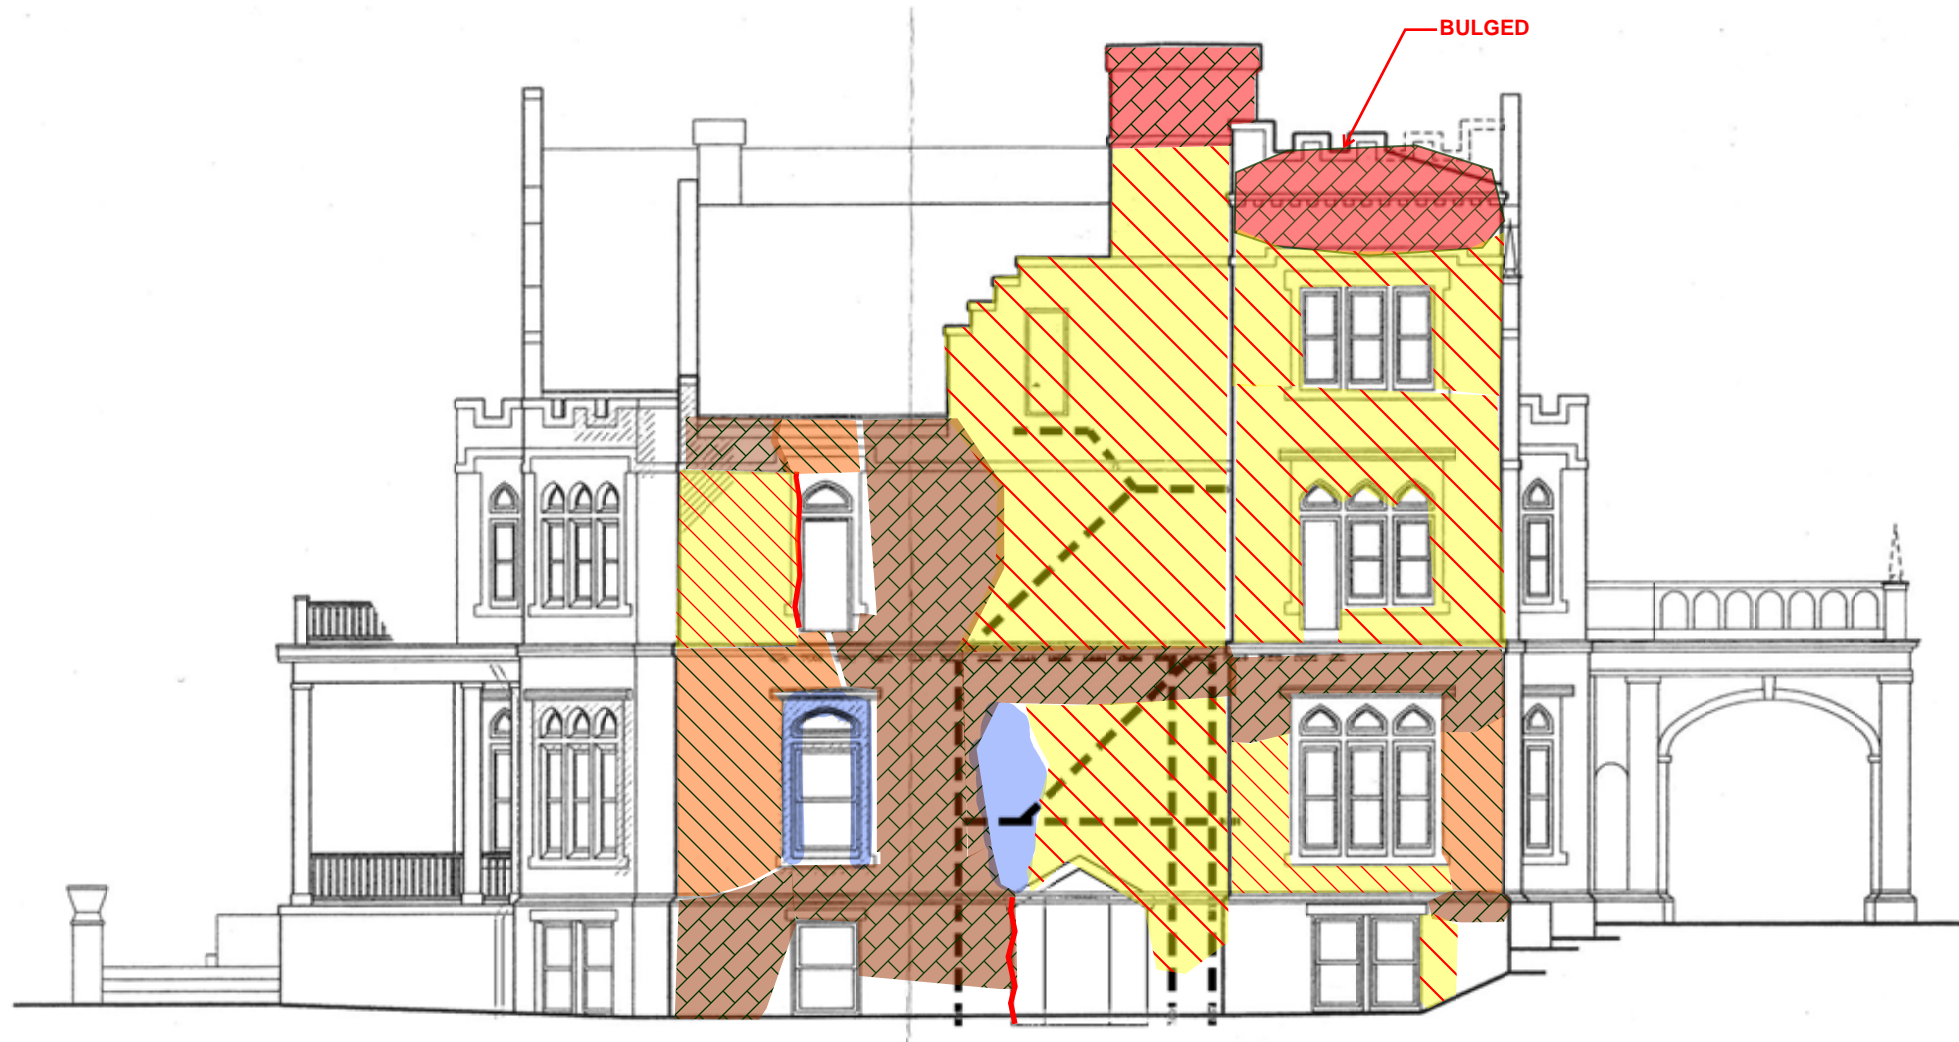
**EM-1**

## EAST ELEVATION

- ITEM #M1: ERODED MORTAR JOINTS- MUST BE CUT AND POINTED
- ITEM #M2: DEEPLY ERODED MORTAR JOINTS, MUST DEEPLY CUT AND POINT, RE-SET STONES THAT LOOSEN DURING CUTTING
- ITEM #M3: TIGHT BUT UNBONDED COLLAR JOINTS AS VIBRATED WHEN TAPPED
- ITEM #M4: DEBONDED WEATHERED MASONRY
- ITEM #M5: BULGED OR SHIFTED FLAT MASONRY, MUST BE STRIPPED AND RE-SET
- ITEM #M6: BULGED OR SHIFTED PROJECTING OR STRUCTURALLY DISTINCT MASONRY, MUST BE REMOVED AND RE-SET
- ITEM #M7: EFFLORESCENT DEPOSITS, SIGN OF DAMNNESS OR LEAKAGE
- ITEM #M8: CRACK THROUGH MORTAR JOINTS, EXCAVATE, POINT AND GROUT, RE-SET STONES ALONG CRACK THAT HAVE LOOSENED

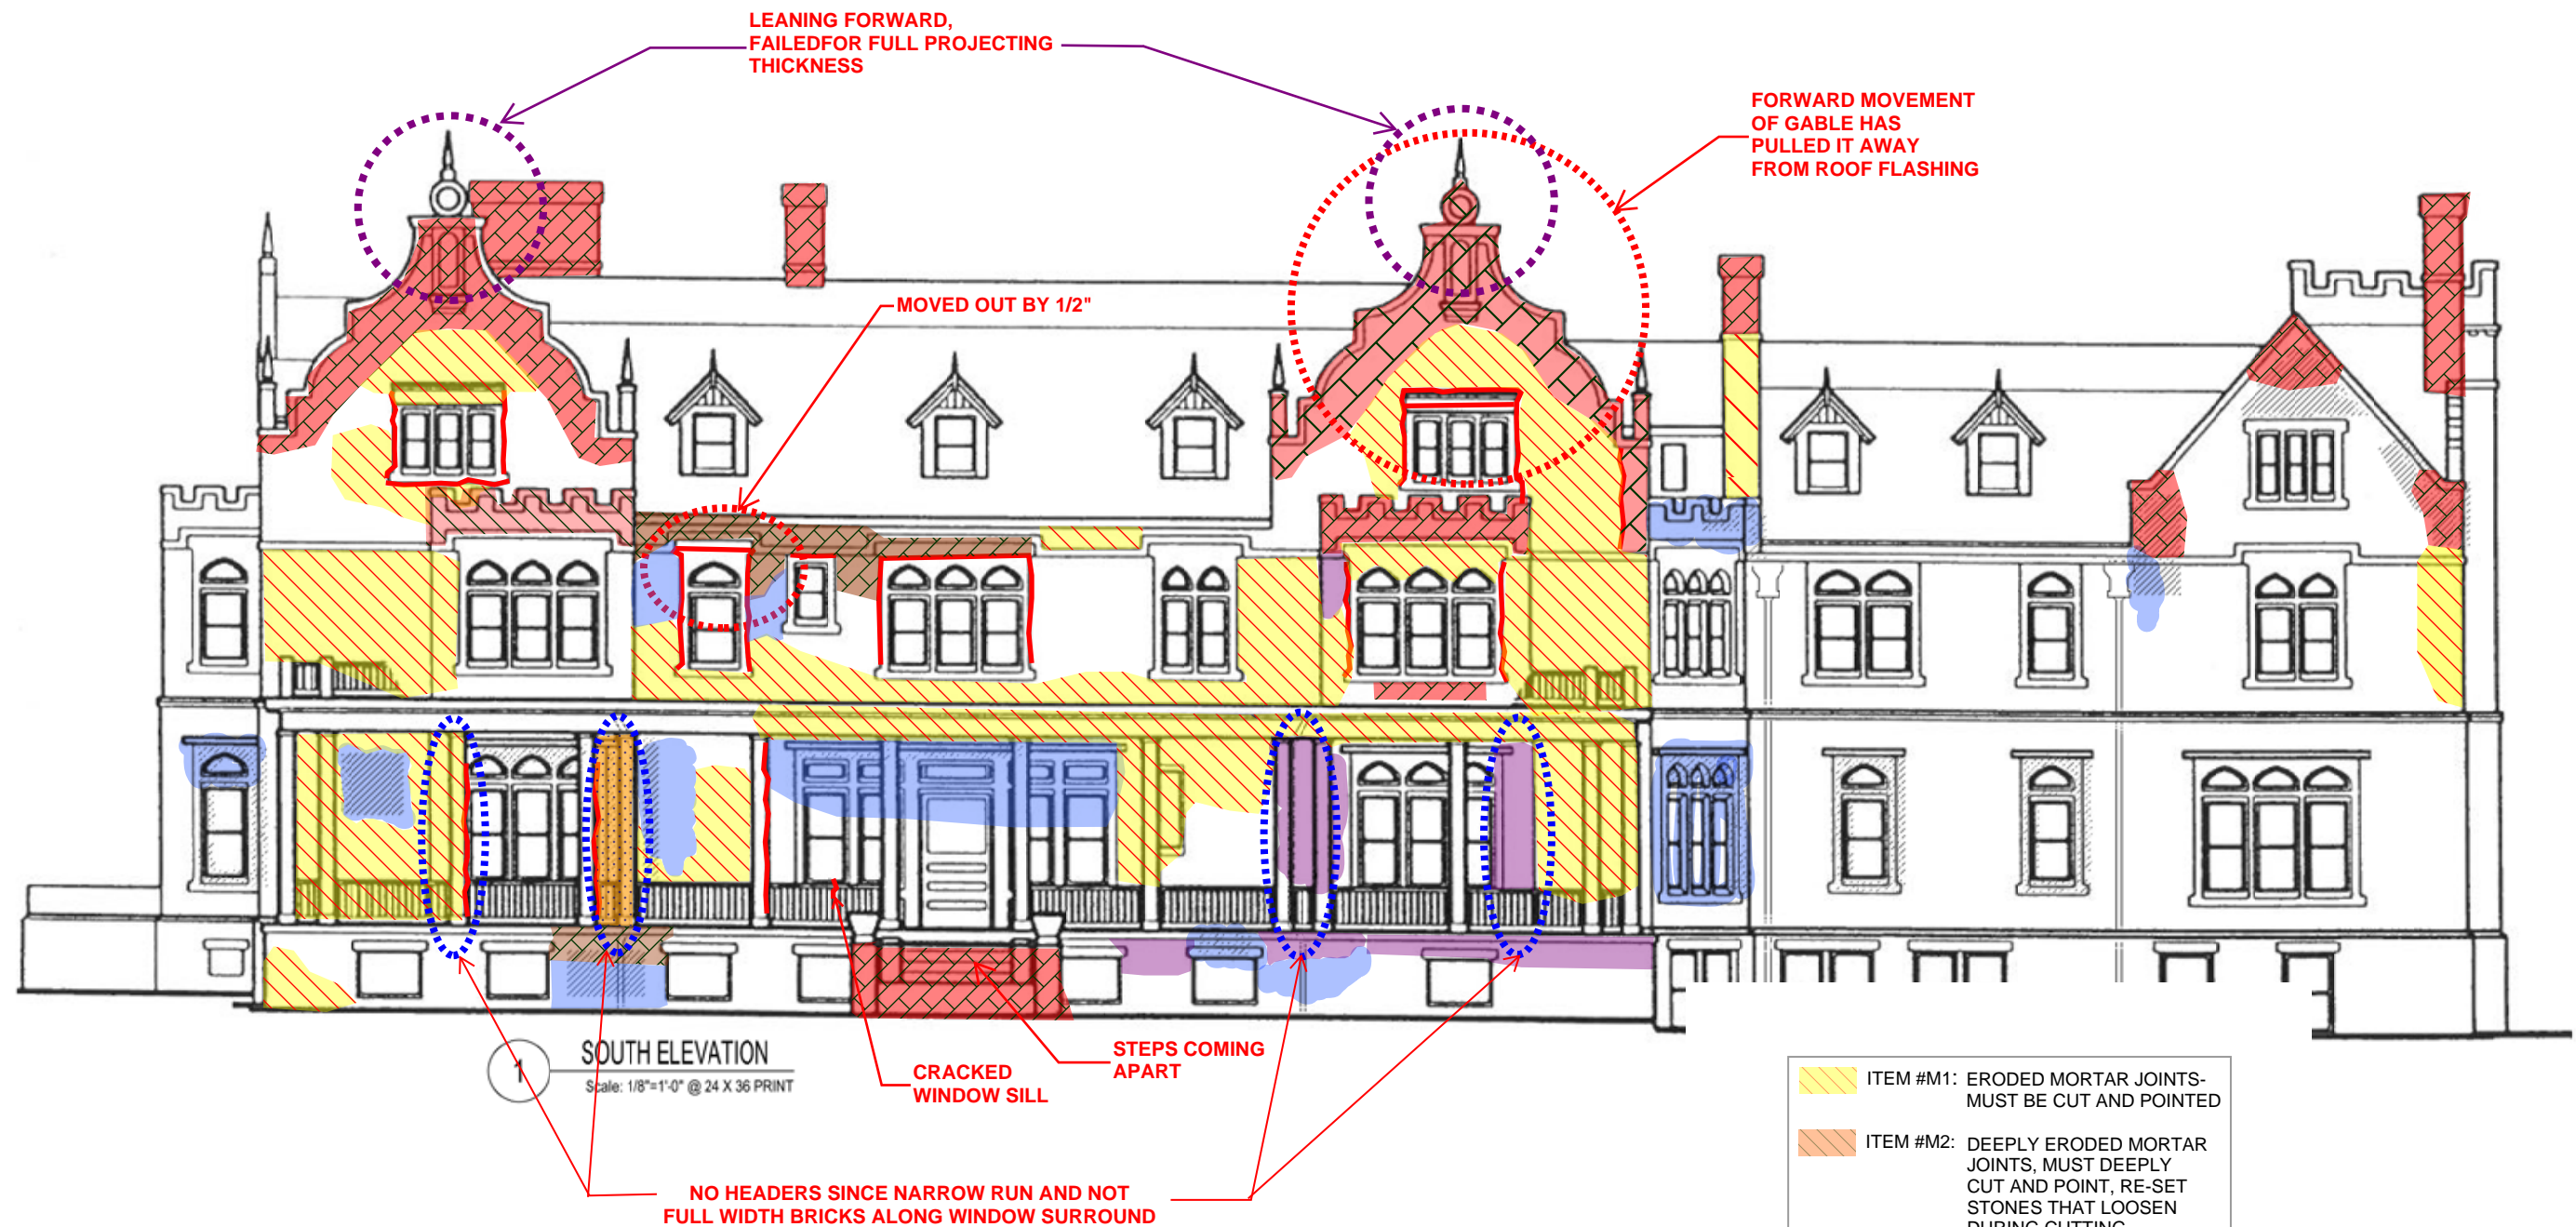
EM-2

- ITEM #M1: ERODED MORTAR JOINTS- MUST BE CUT AND POINTED
- ITEM #M2: DEEPLY ERODED MORTAR JOINTS, MUST DEEPLY CUT AND POINT, RE-SET STONES THAT LOOSEN DURING CUTTING
- ITEM #M3: TIGHT BUT UNBONDED COLLAR JOINTS AS VIBRATED WHEN TAPPED
- ITEM #M4: DEBONDED WEATHERED MASONRY
- ITEM #M5: BULDGED OR SHIFTED FLAT MASONRY, MUST BE STRIPPED AND RE-SET
- ITEM #M6: BULDGED OR SHIFTED PROJECTING OR STRUCTURALLY DISTINCT MASONRY, MUST BE REMOVED AND RE-SET
- ITEM #M7: EFFLORESCENT DEPOSITS, SIGN OF DAMNESS OR LEAKAGE
- ITEM #M8: CRACK THROUGH MORTAR JOINTS, EXCAVATE, POINT AND GROUT, RE-SET STONES ALONG CRACK THAT HAVE LOOSENED

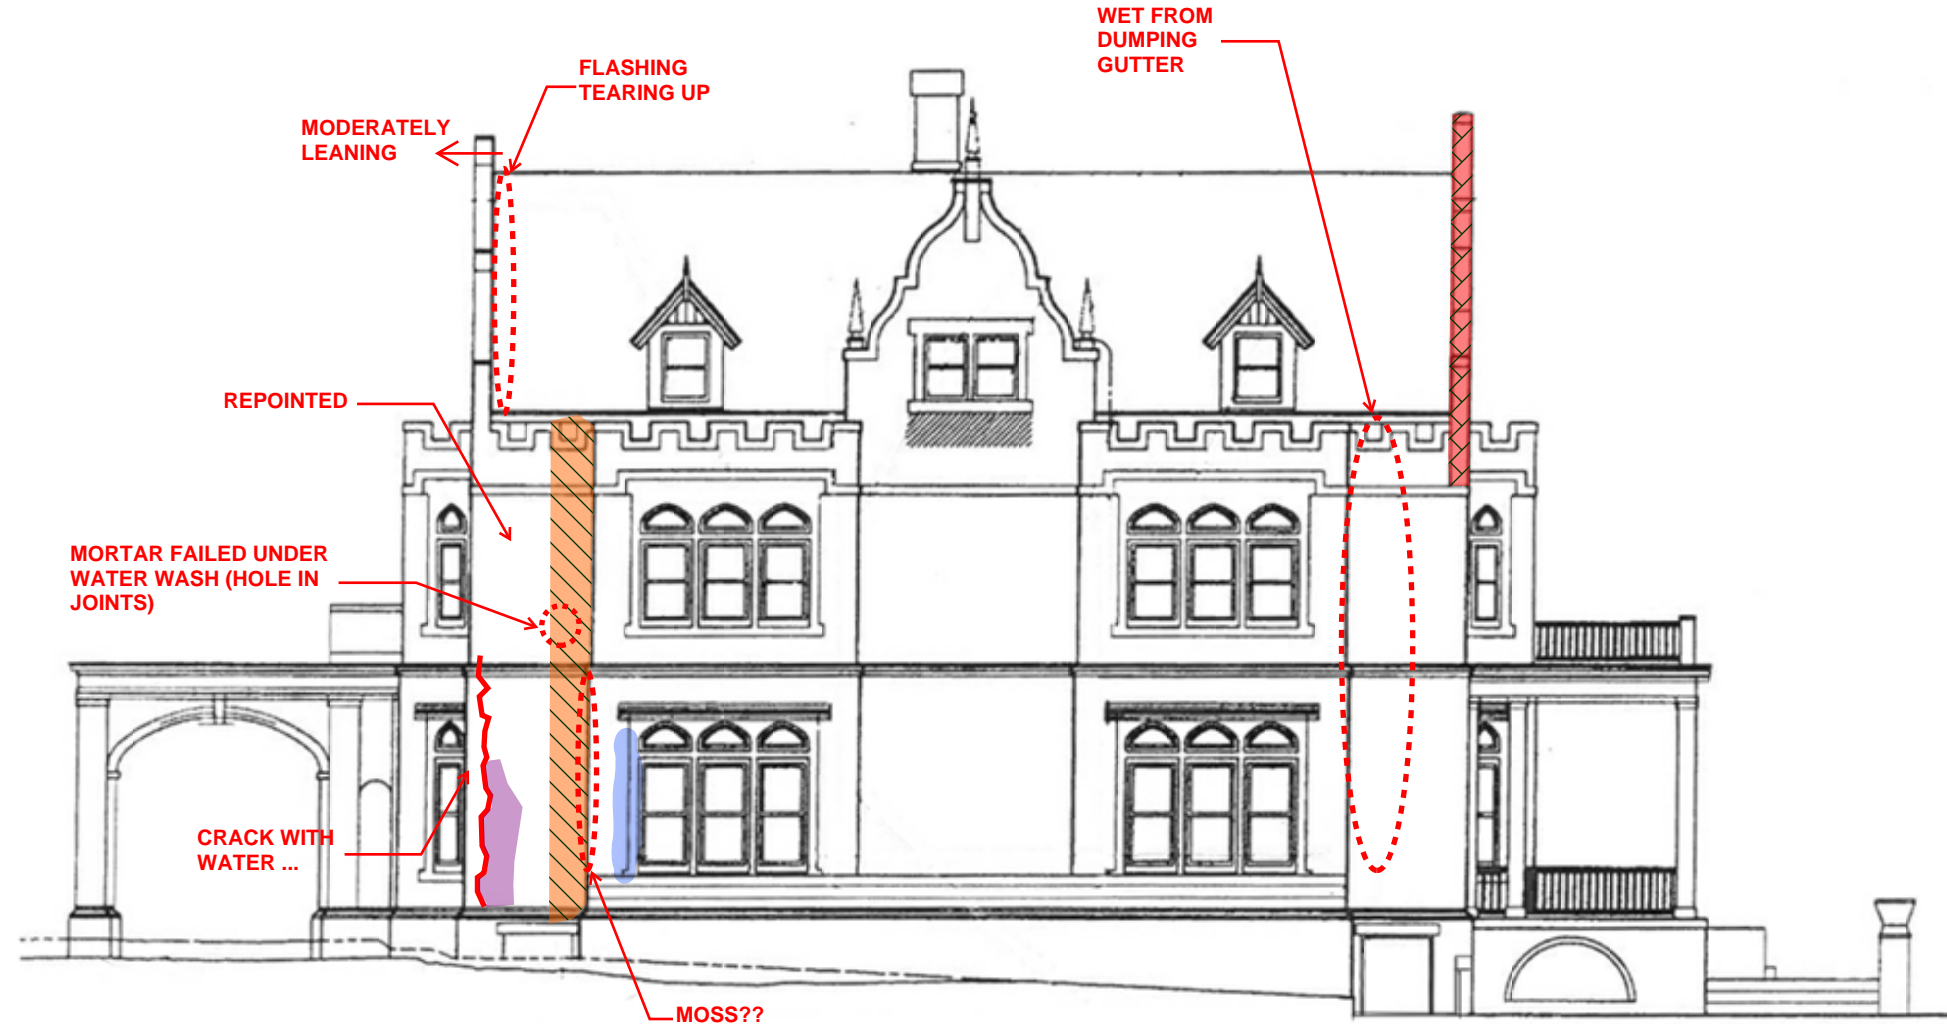
# EM-3

- ITEM #M1: ERODED MORTAR JOINTS- MUST BE CUT AND POINTED
- ITEM #M2: DEEPLY ERODED MORTAR JOINTS, MUST DEEPLY CUT AND POINT, RE-SET STONES THAT LOOSEN DURING CUTTING
- ITEM #M3: TIGHT BUT UNBONDED COLLAR JOINTS AS VIBRATED WHEN TAPPED
- ITEM #M4: DEBONDED WEATHERED MASONRY
- ITEM #M5: BULGED OR SHIFTED FLAT MASONRY, MUST BE STRIPPED AND RE-SET
- ITEM #M6: BULGED OR SHIFTED PROJECTING OR STRUCTURALLY DISTINCT MASONRY, MUST BE REMOVED AND RE-SET
- ITEM #M7: EFFLORESCENT DEPOSITS, SIGN OF DAMNESS OR LEAKAGE
- ITEM #M8: CRACK THROUGH MORTAR JOINTS, EXCAVATE, POINT AND GROUT, RE-SET STONES ALONG CRACK THAT HAVE LOOSENED

1 WEST ELEVATION  
Scale: 1/8"=1'-0" @ 24 X 36 PRINT

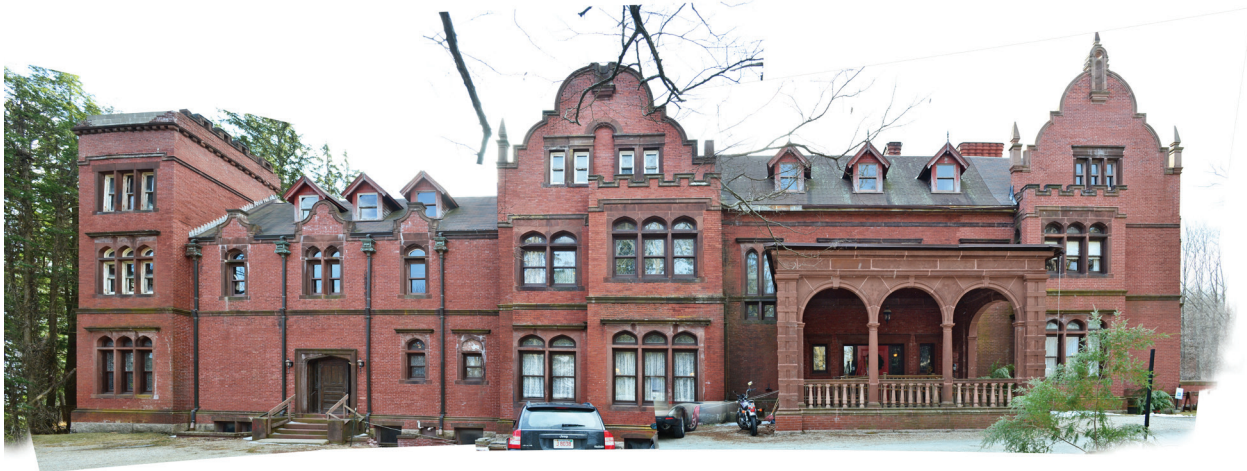
North elevation - photo montage. 2016.

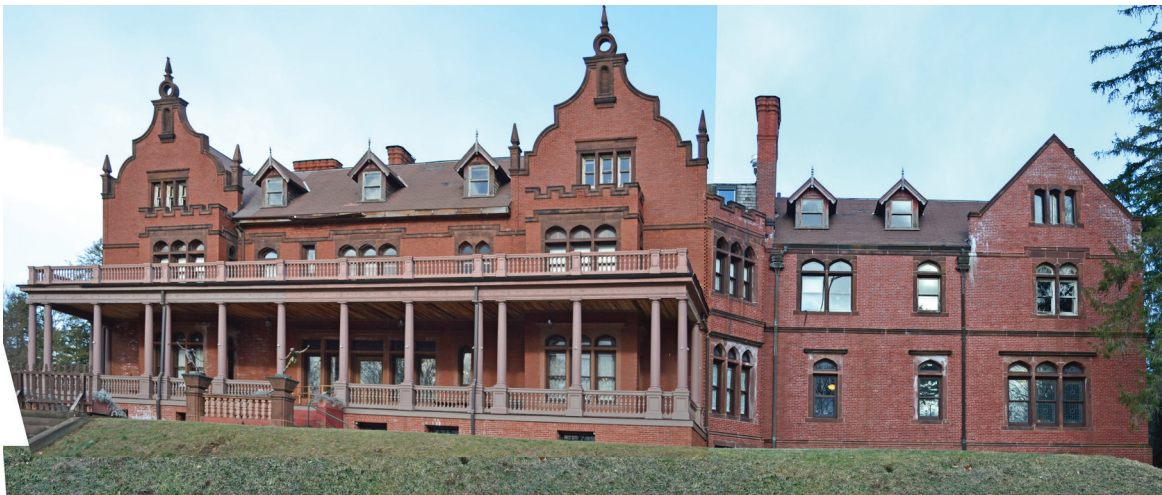
South elevation - photo montage. 2016.

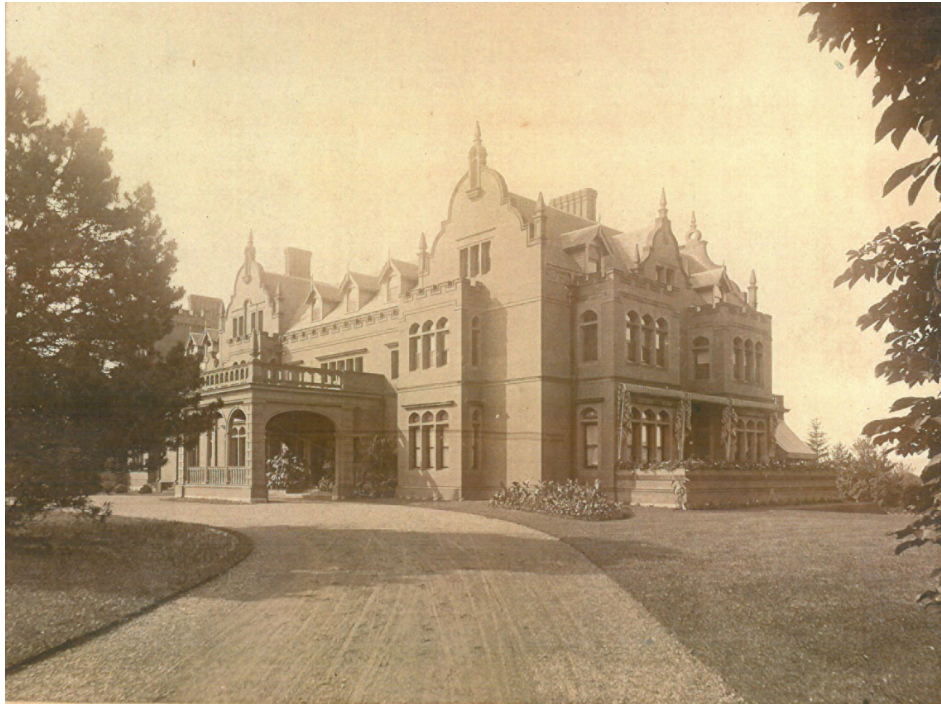
North and west elevations soon after completion in 1893. Note the walled terrace and awning at the west elevation and the upper balustrade at the porte cochere.

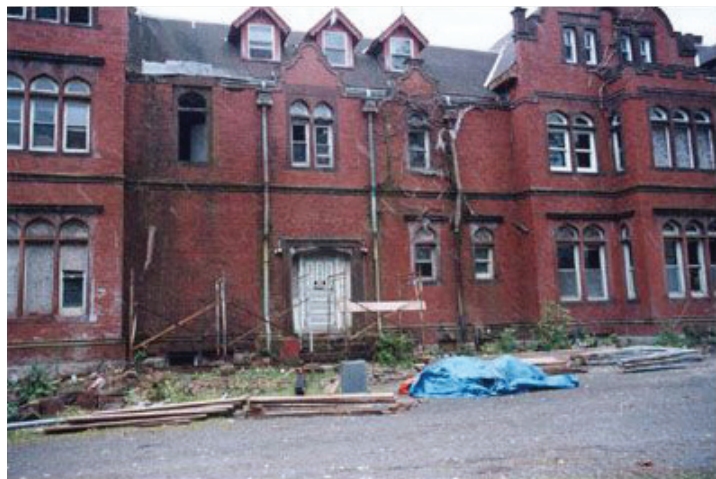
North elevation in 1997. Note the missing shaped gable (over missing sash at second story) allowing damaging water penetration to wall and interior.

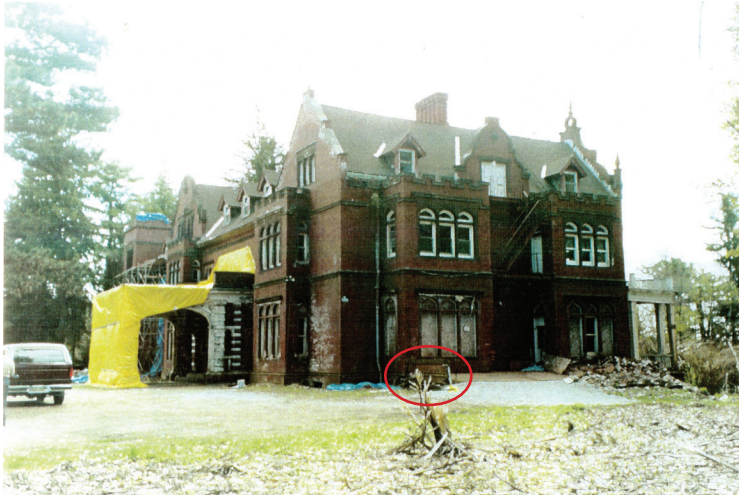
North and west elevations. April, 1998. Masonry work in progress at north elevation. Porte cochere partially covered by a tarp. A remnant of the original terrace wall can be seen at the red circle.

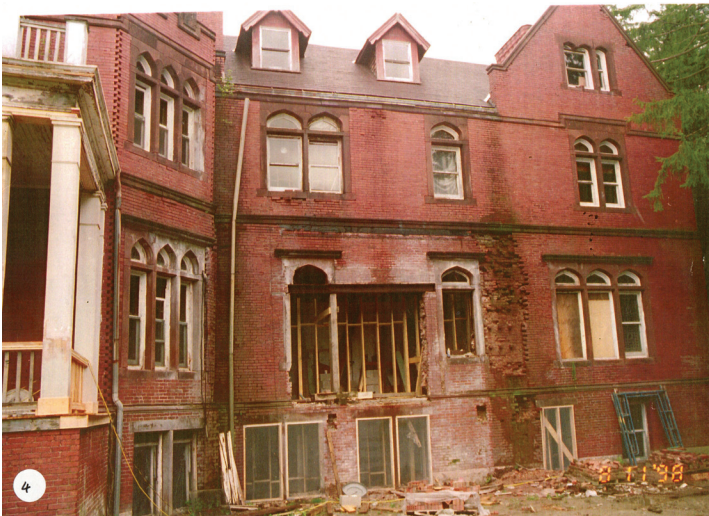
South elevation. Wooden shed-roofed "pizza kitchen" addition removed. 1998.

The south elevation where the pizza kitchen addition had been removed was addressed next. The area of missing brick was refilled and the adjacent diagonal dining room wall was rebuilt. The masons encountered the same problem here that was seen on the north elevation – veneer brick detached from back-up brick. Most of the original face brick was reused in these repairs but it was necessary to add about 20 percent new brick using a locally produced material that was close in color and texture to the original.

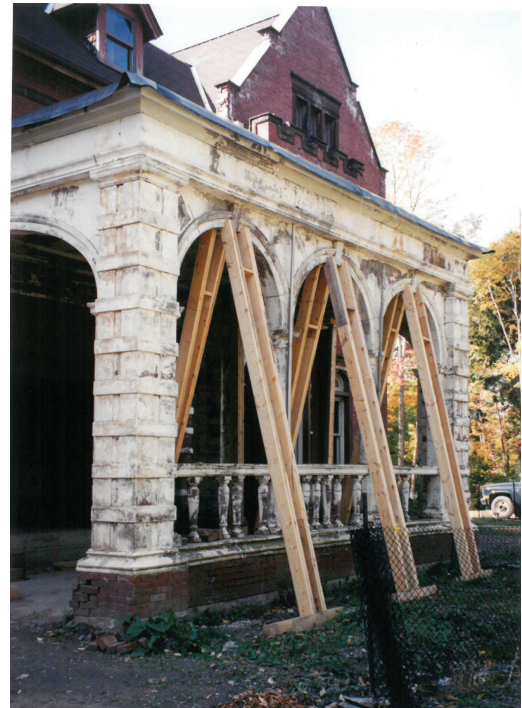
North elevation. Porte cochere shored up prior to disassembly and reconstruction. 1999.

In 1997-98 the porte cochere roof was structurally reinforced and rebuilt but continued to leak. The following year the structure was shored up with wood supports, but by early 2000 the stones began to shift. The structure was disassembled and the stones cleaned of white paint and then reinstalled. The porte cochere was rebuilt on a new foundation with new cast stone balusters built to replicate the originals. The arched roof balustrade seen on early photographs was not recreated; remnants of original upper balustrade stones were found in 1999 behind the carriage house. In 2007 a permanent new ceiling was installed.

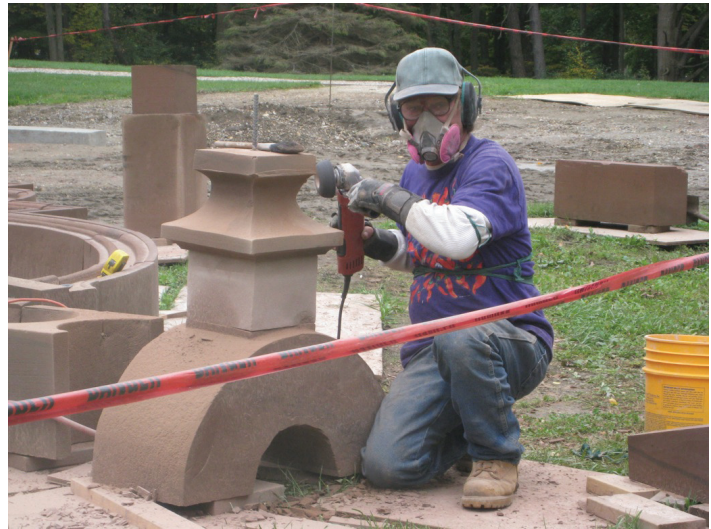
Fabricating finial ornament for south elevation gable peak.

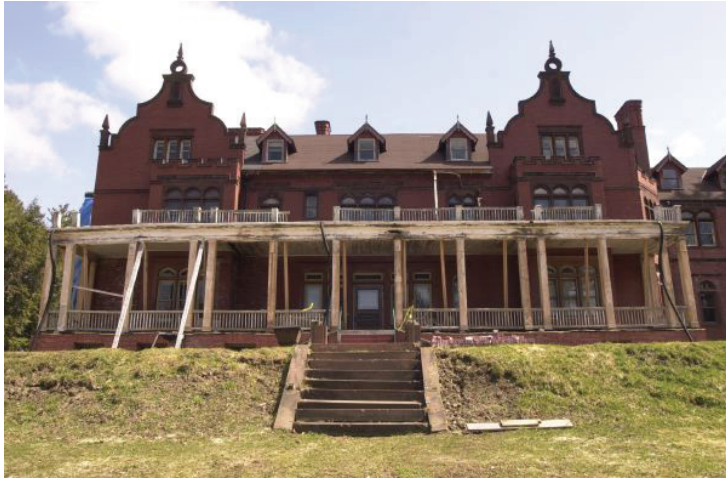
South porch shored up. April 2001.

In 2002 the restoration of the south porch was completed. The structure and details were recreated based on historic photographs and a single extant original baluster. The original ceiling boards and copper floor plan were reused but membrane roofing replaced the original metal. The wood was painted to match the brownstone color of the house as it appeared in early images. The stone steps at the porch were rebuilt with cast stone balusters and a new carved stone top rail; the baluster molds were created from a plaster model based on early photographs.

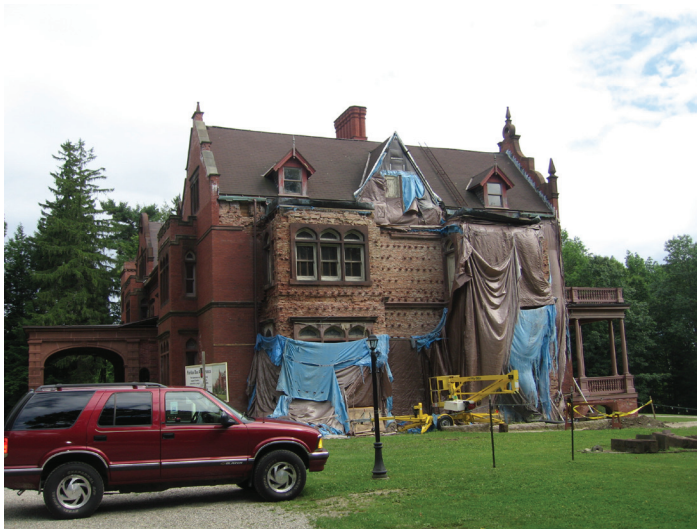
West elevation. July 2007. Rebuilding the west wall.

Additional masonry repairs took place in 2007-2009, including rebuilding of the west elevation and installation of new carved stones over the north entrance. A new basement entrance was created along with a new foundation for an eventual front gateway.
